April 12, 2021

Matt Duncan, CAM
The Summit Owner's Association, Inc.
8743 Thomas Drive
Panama City Beach, FL 32408

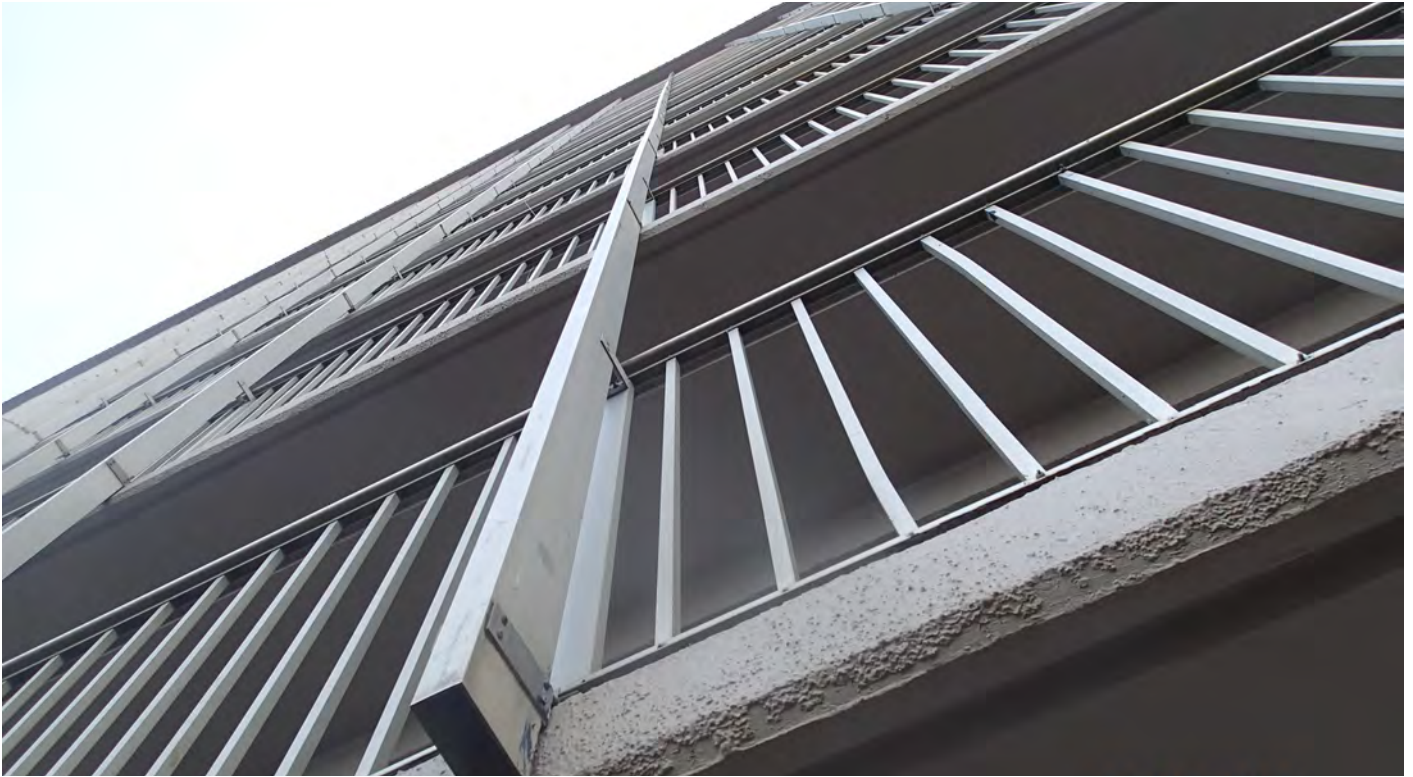
Figure 1: Typical handrail connections on building.

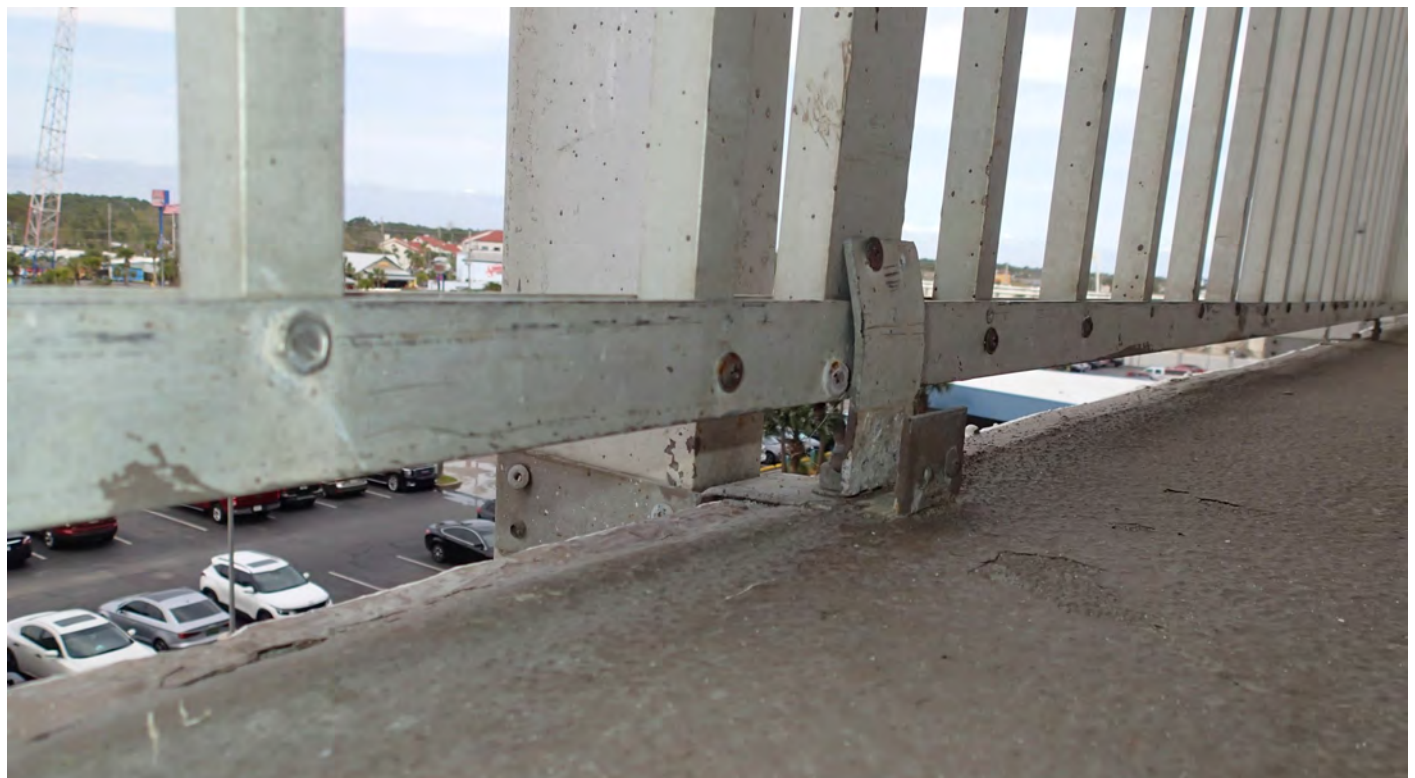
Figure 6: Typical handrail connections are modular, and rely on screws and rivets for connections. Many fasteners are broken, loose, and missing.

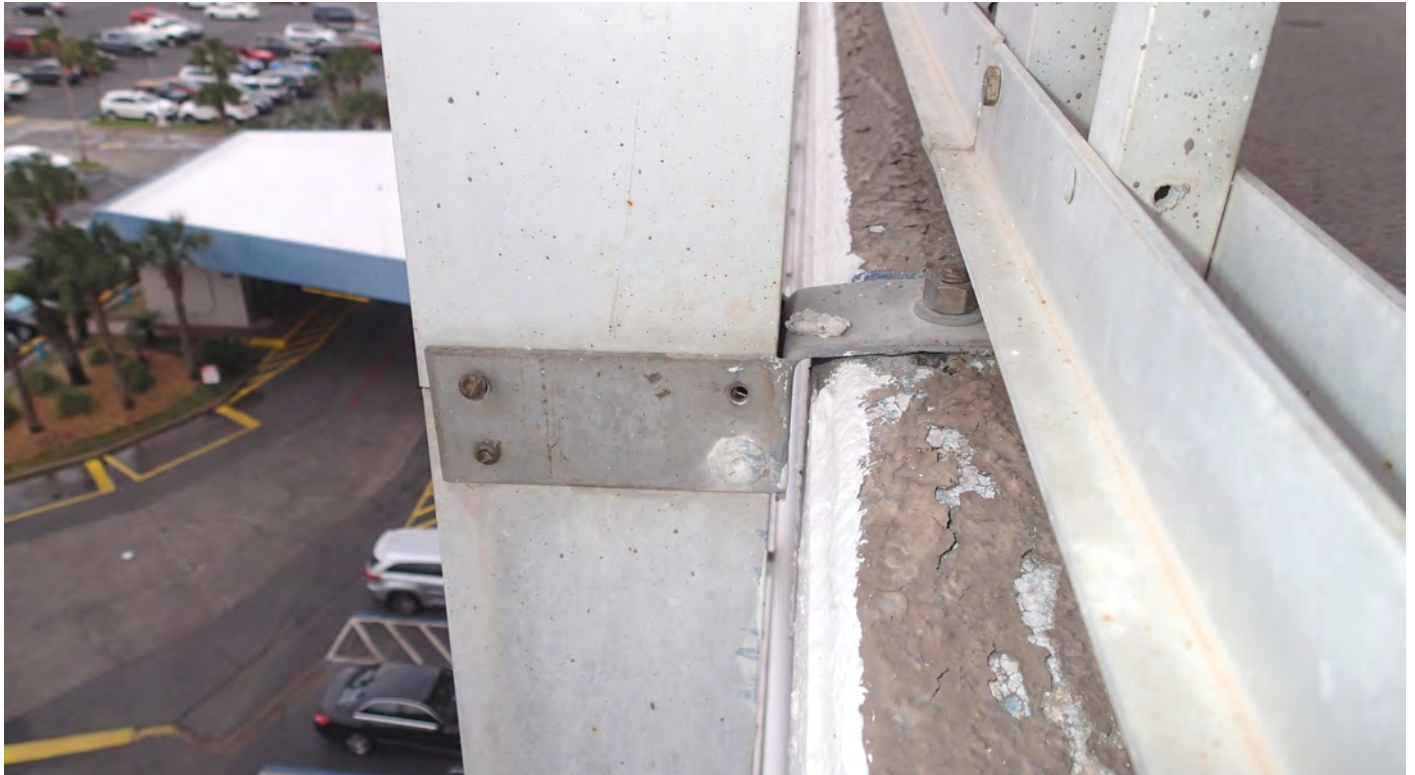
Figure 7: Typical main column connections to building with missing and broken screws.

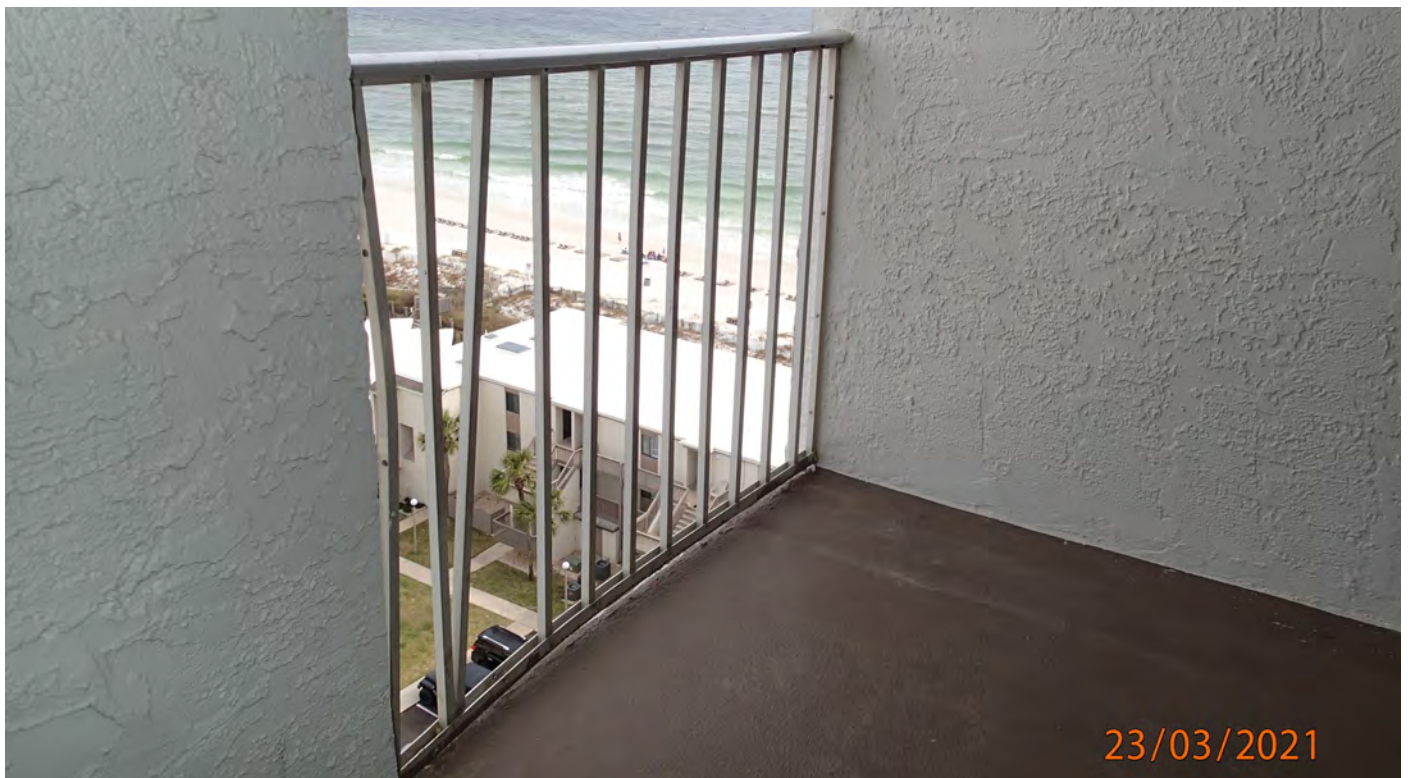
Figure 8: Damaged end rail with broken picket.

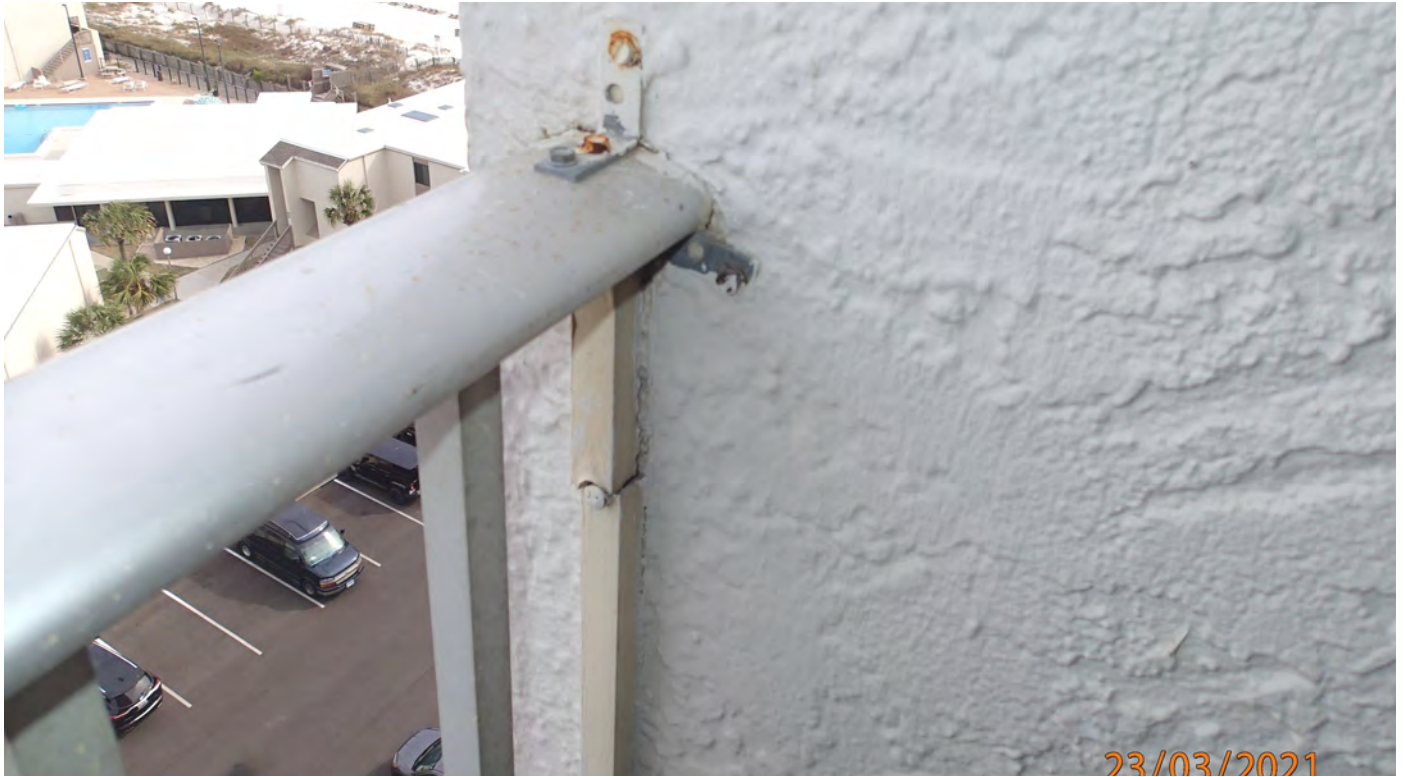
Figure 9: Typical repairs on handrails are insufficient.

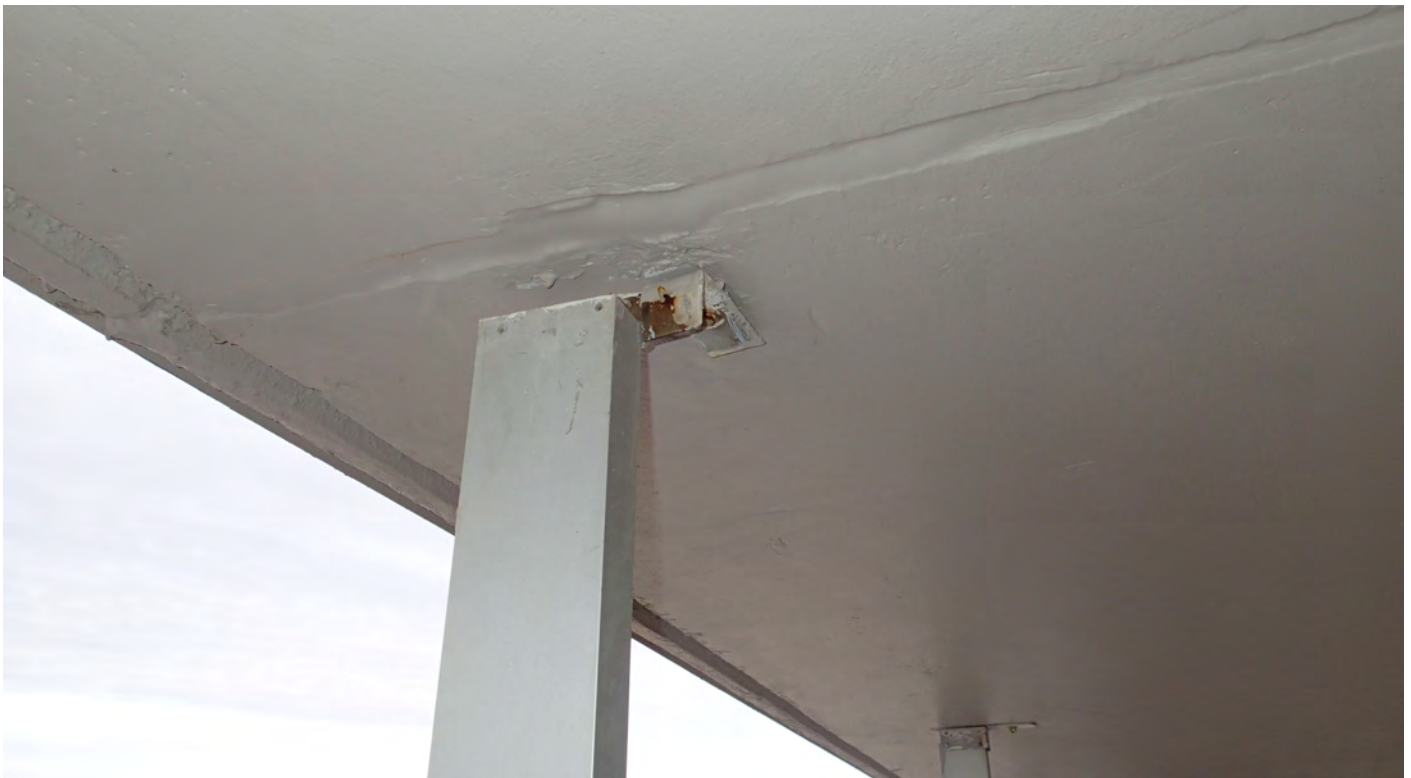
Figure 10: 15th floor—Connections at the top of main support columns. Some are loose or broken.

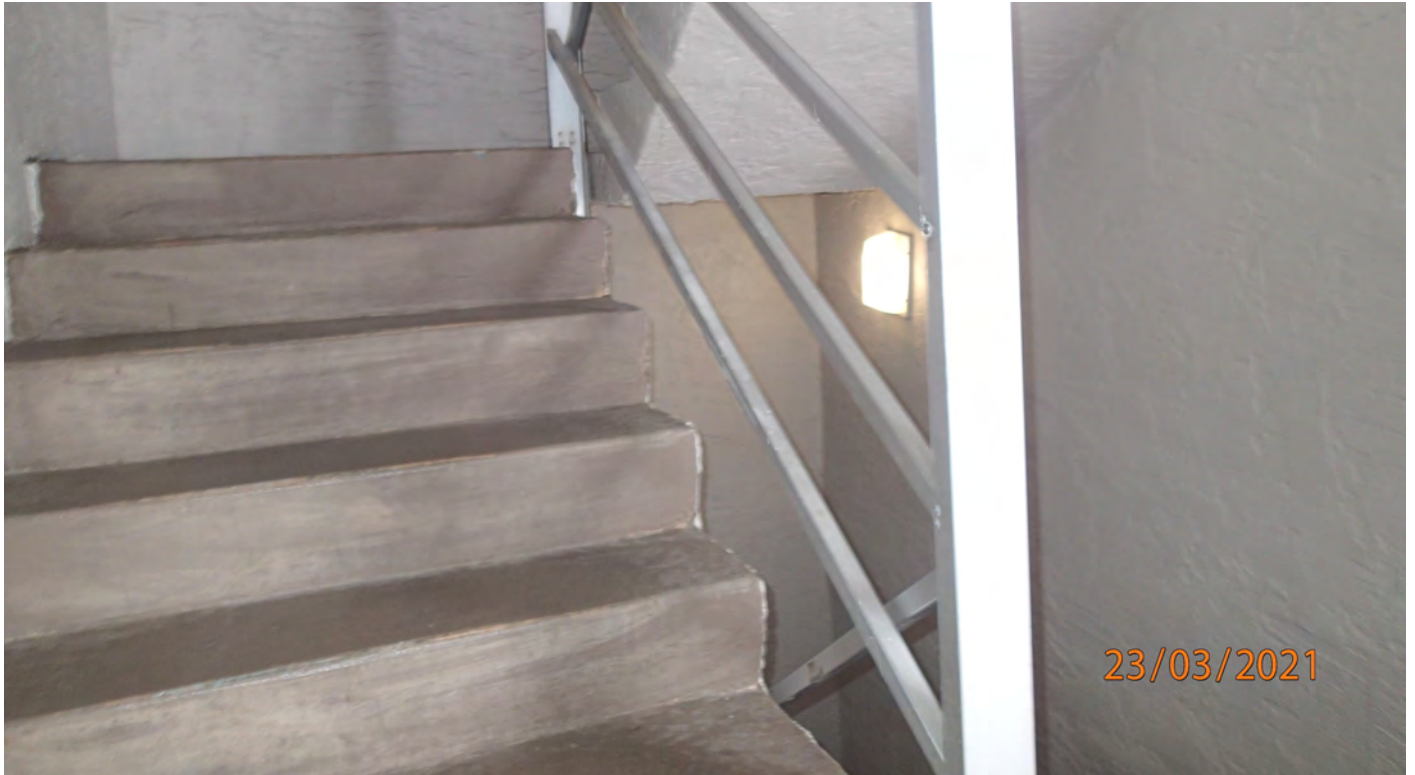
Figure 11: Most stairs do not have ant-slip surface on treads. Inspection was done during a rain event. Stairs are slippery when wet.

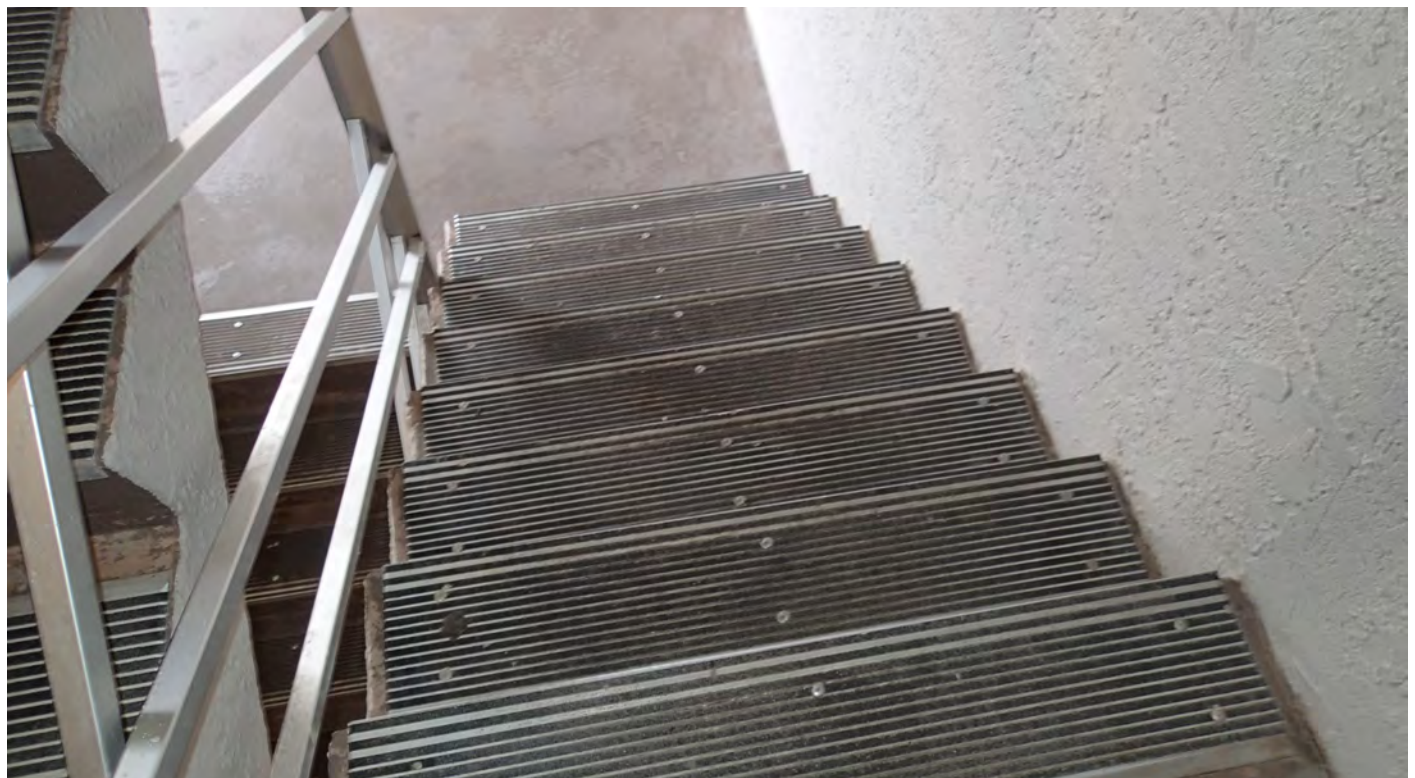
Figure 12: Recommended treatment for stairs to prevent slippage.
