General Observation Report

Christopher Hernandez
chernandez@csharpe.com

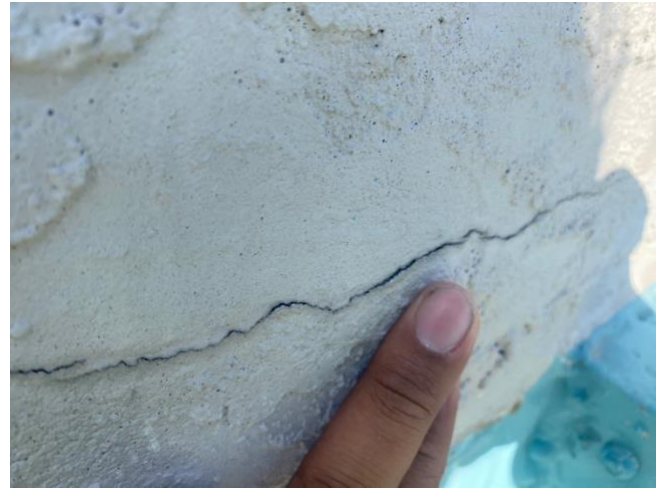
West area. Cracking forming along the stucco and delaminating.

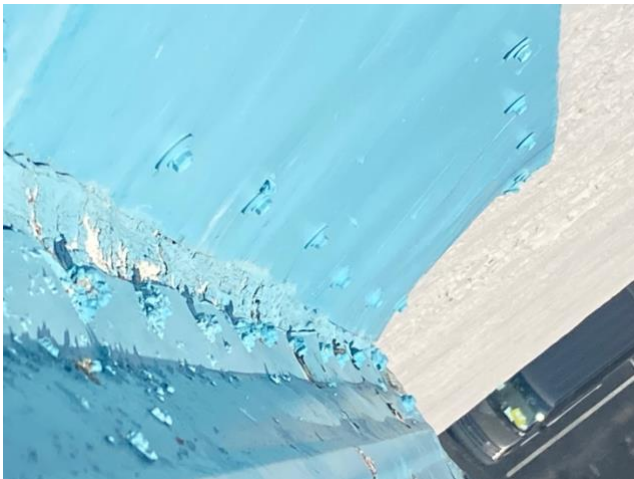
West area. Coatings on sealant failing and sealant exposed to direct sunlight. Sealant appears to have voids as well.

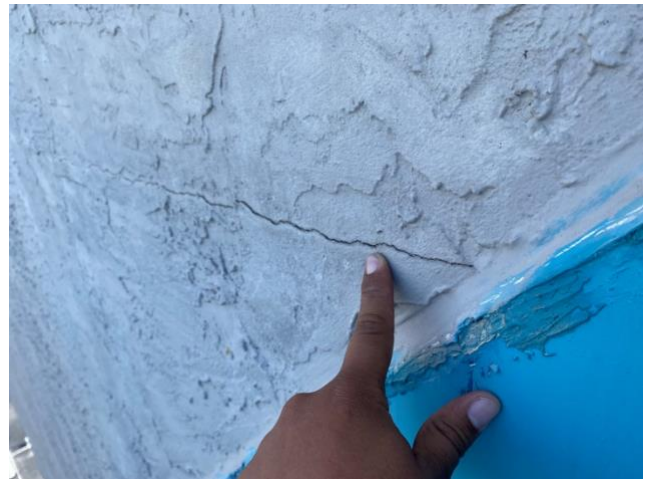
East area. Stucco appears to have been patched prior and the patch is delaminating. Crack also runs from one end of the repair to the next.

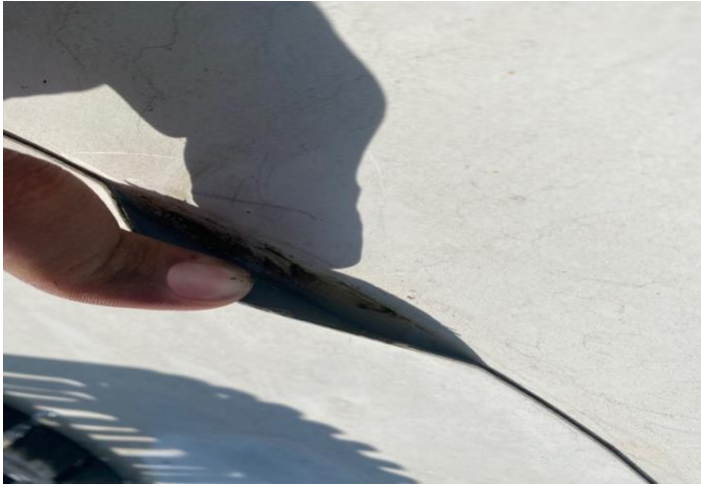
East area. TPO roof is peeling around the drain the drain.

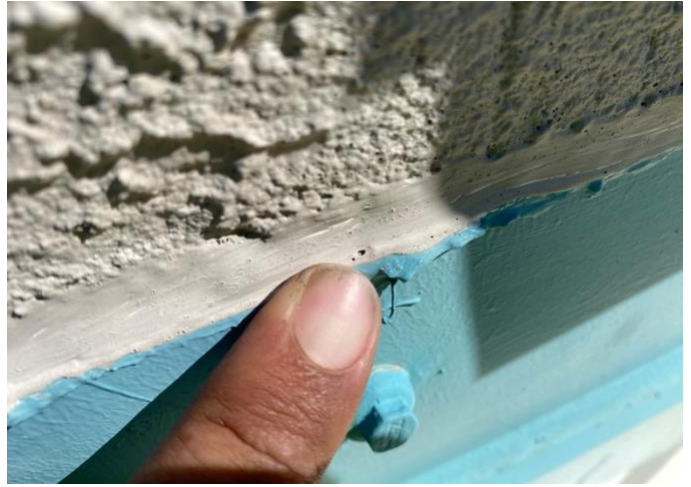
East area. Multiple voids observed in the sealants above flashing.

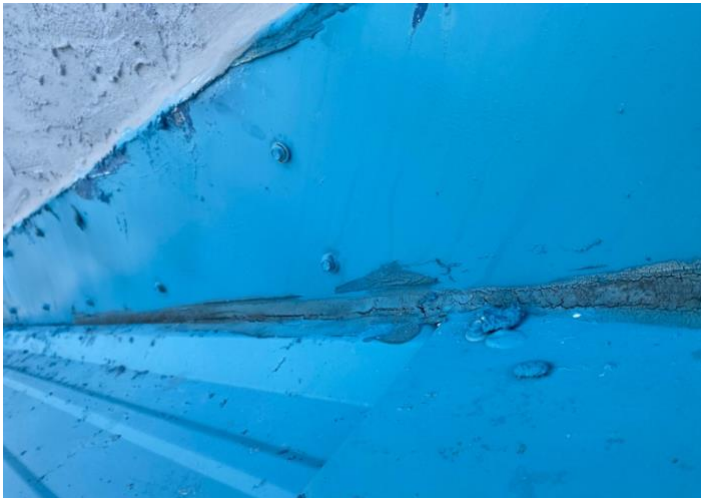
East area. Coatings on sealants failing. Sealant also appears to be cracking in multiple locations.
